Nondestructive Evaluation of

Provided by: HurleyIR

[REDACTED], HurleyIR provided a nondestructive evaluation for [REDACTED]

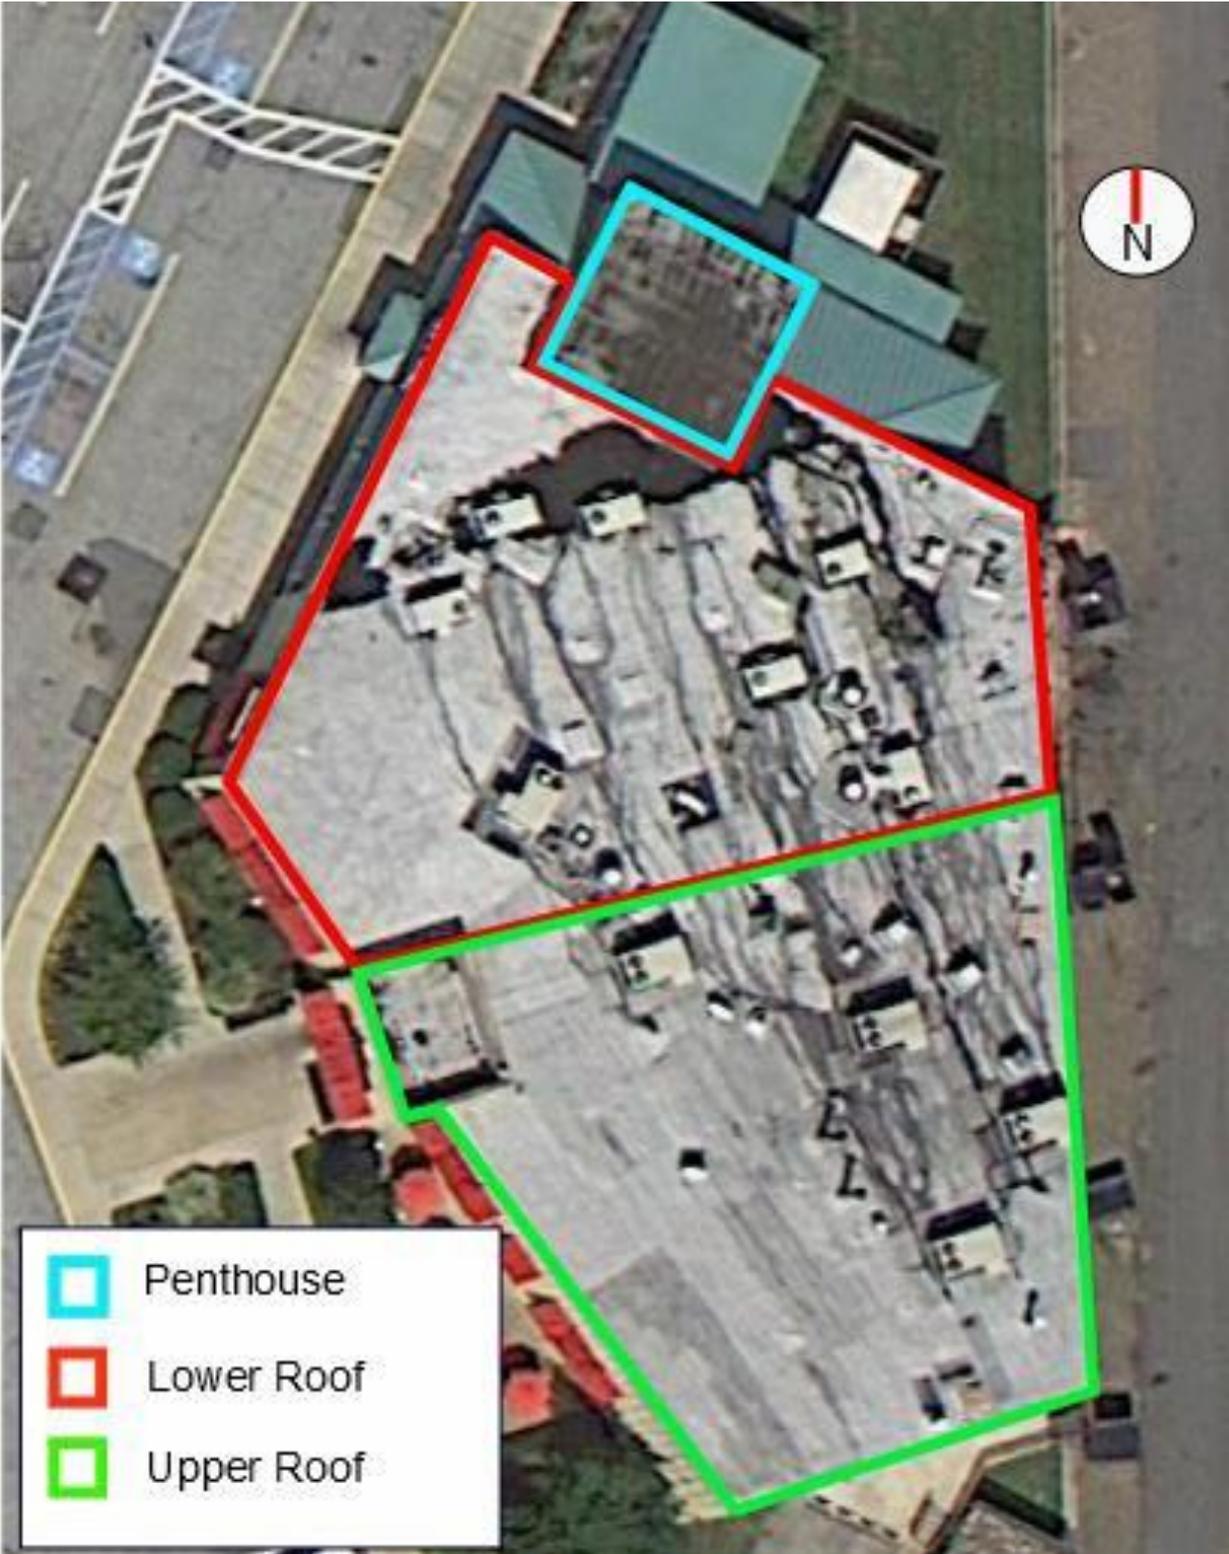
This image lays out the different sections of the entire roof.

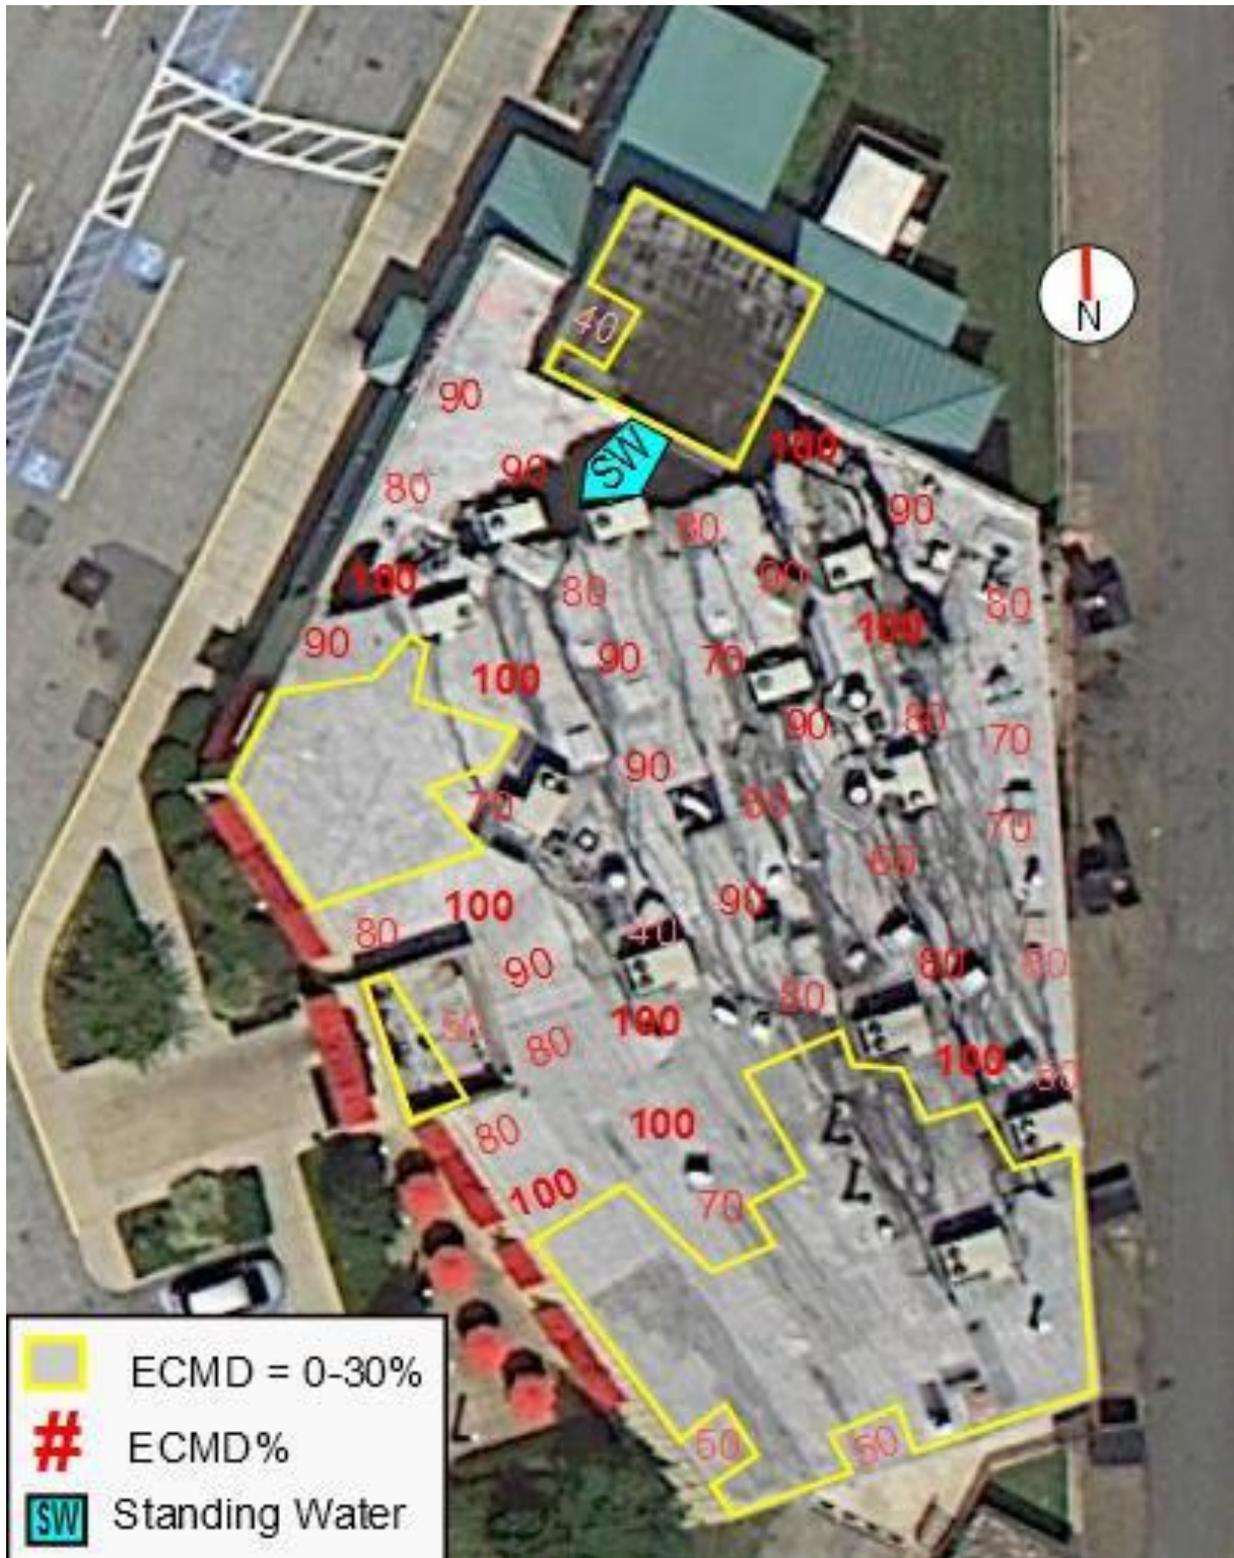
After performing two NDT tests, HurleyIR found a total of only two regions on the roof that did **not** have patterns and/or measurements indicative of entrapped moisture. Of the three areas marked with red marking paint on the roof, two are showing good areas, while one is showing a bad area. The good area of the upper roof measured to be nearly 3,500ft², while the other good areas on the lower roof and penthouse collectively measured approximately 1,100ft². The marked bad area, located between the two good areas contains a marked "x", representing a good place for a core/cut verification test to be taken in order to verify the NDT and determine the magnitude of saturation and types of materials. Both the ECMD and the IRT tests' results correlated revealing the same areas of moisture readings throughout the main elevation; both NDT methods detected a total of 9,000ft² of saturated material, or approximately 66% of the entire roof.

This image shows the percentages detected by the ECMD during the NDT evaluation.

of materials to be removed and inspect the deck system. Presuming verification samples substantiate the NDT findings it is our recommendation for a total roof tear off and replacement.

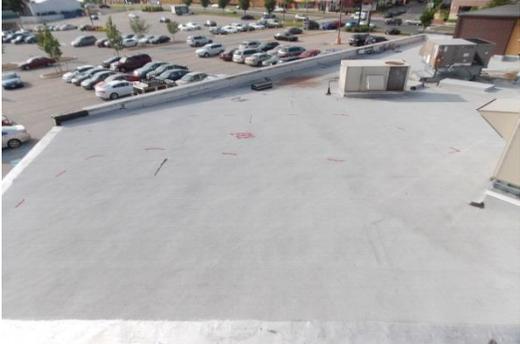
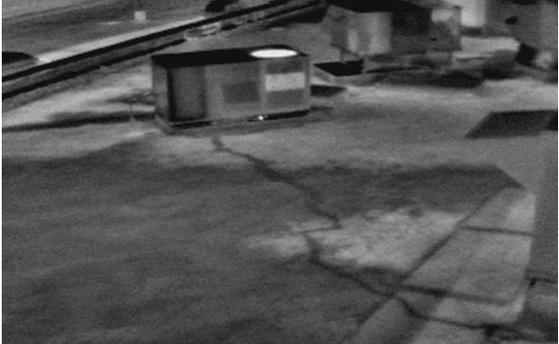
1

These images were taken during the IRT portion of the NDT evaluation. Images on the left are in the visual spectrum, while the images on the right are in the Infrared spectrum. Lighter areas represent the saturated materials detected, while dark images represent unsaturated materials.
